# Wet-Reflective Pavement Marking Demonstration Project

**Final Report**  
**November 2011**

**Sponsored by**  
Iowa Highway Research Board  
(IHRB Project TR-597)  
Iowa Department of Transportation  
(InTrans Projects 08-332 and 08-333)

# **WET-REFLECTIVE PAVEMENT MARKING DEMONSTRATION PROJECT**

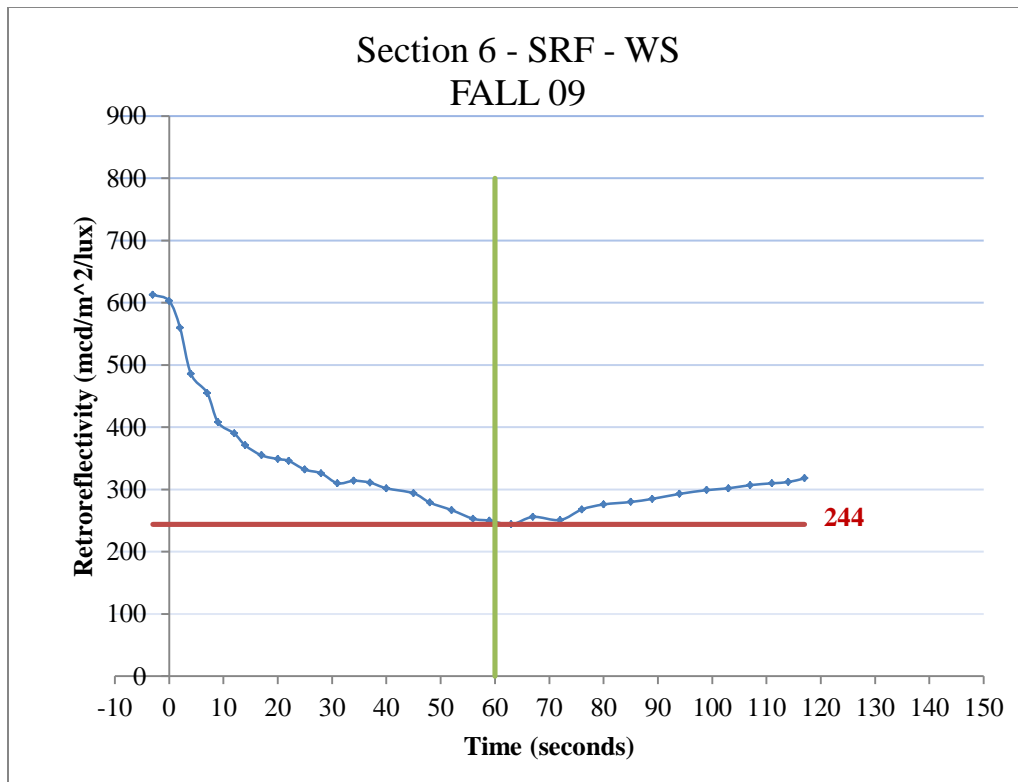
**Figure 13. Sample wet retroreflectivity readings (from test section 6)**

The above procedure allowed the research team to graph the retroreflectivity performance of each product over time. Figure 13 shows an example of the data as plotted with the initial dry readings (two) on the y axis and a green line which represents the end of one minute (wetting period), followed by continued readings to capture recovery. The red line identifies the wet retroreflectivity at one minute.

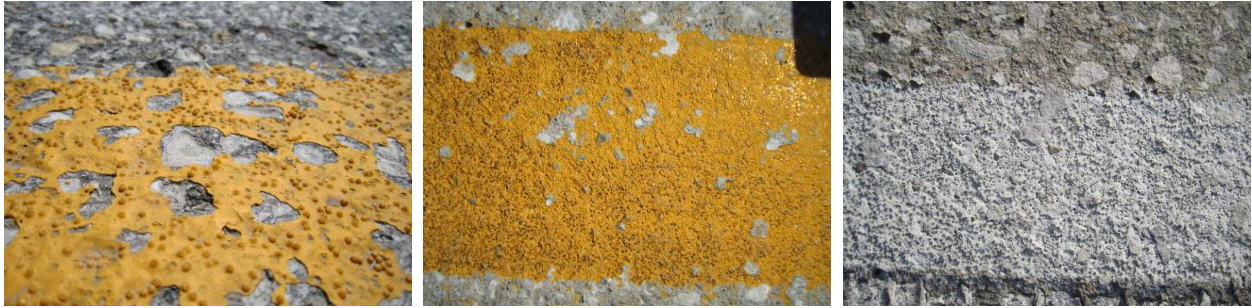
**Figure 15. Material loss on paint products after two winters**

Sections 4, 5, and 15 - Waterborne paint products – All of the paint test sections showed material loss after one and especially after two winters. Figure 15 shows sample material loss after two winters.
