The Challenges and Implications for Energy Education Following the Fukushima Nuclear Accident

Patrick A. Tebbe, Ph.D., P.E. (MN)
Mechanical and Civil Engineering Department
Minnesota State University, Mankato
Presented June 13, 2012

Outline

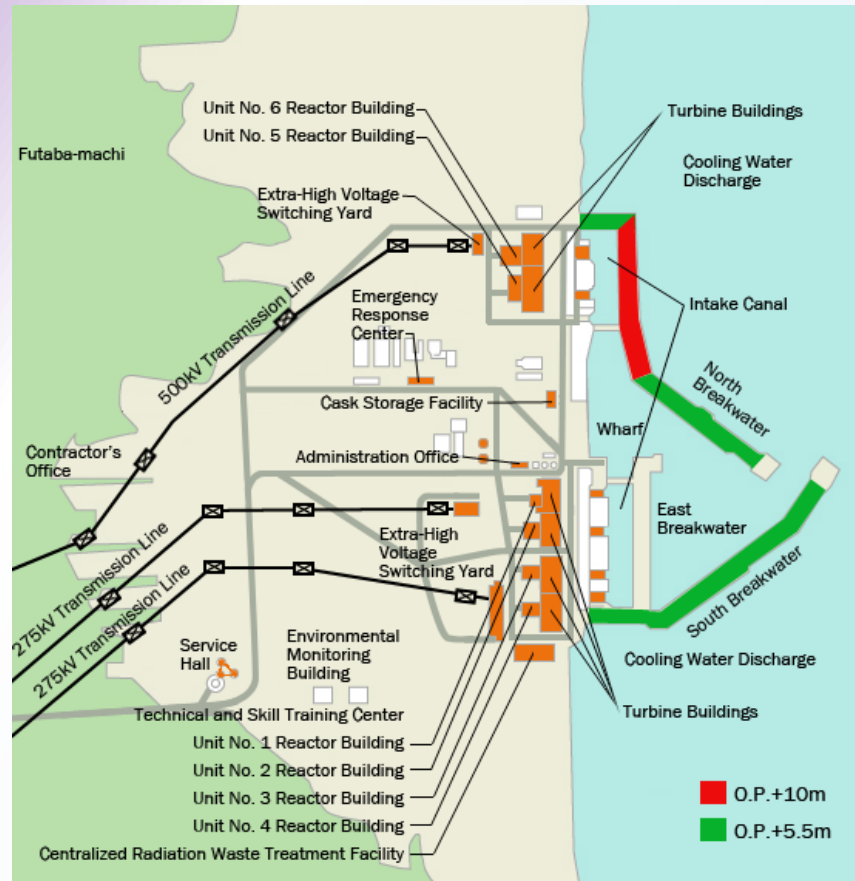
Earthquake and Tsunami

- At 2:46 p.m. on March 11, 2011 an earthquake measuring 9.0 on the Richter scale occurred off the coast of Fukushima Daiichi.
- The first of seven tsunamis reached the plant forty-one minutes later.
- The maximum tsunami height was 46 to 49 ft (14 to 15 m).
- The plant's tsunami design height was 18.7 ft (5.7 m).
- The site grade level for units 1-4 was 32.8 ft (10 m).

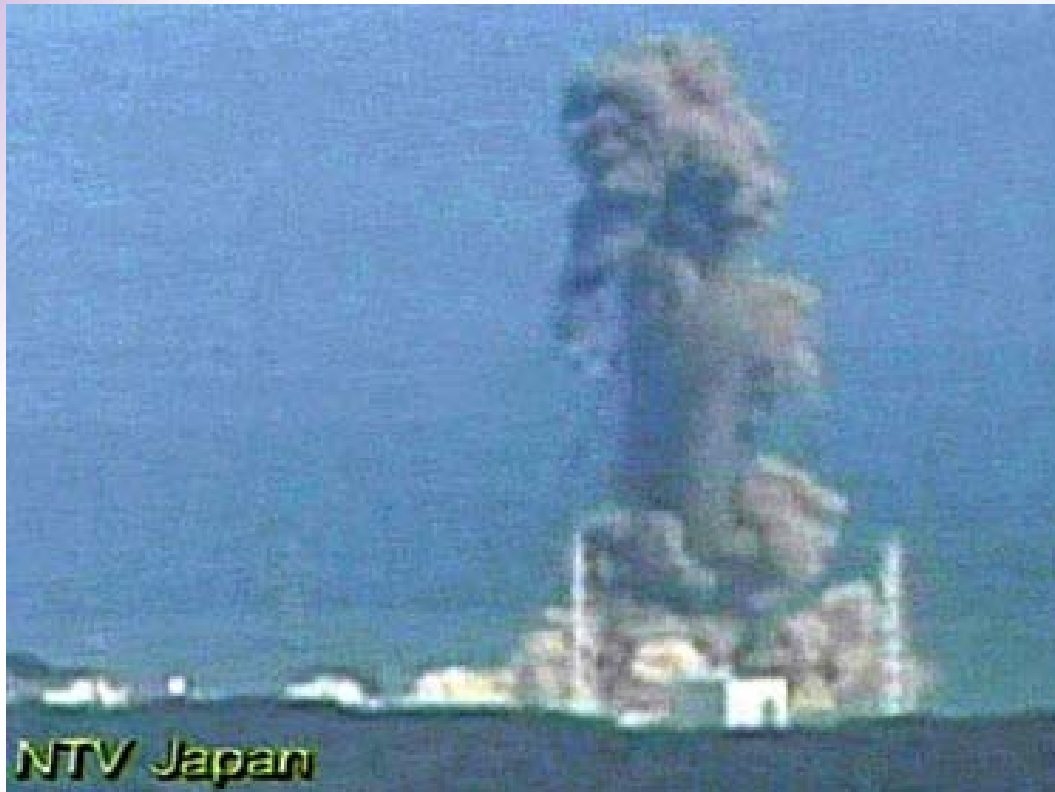
Unit 4 Summary

- Unit 4 lost cooling and water supply to the spent fuel pool. The pool temperature increased.
- At 6 a.m. on March 15th a hydrogen explosion occurred.
- It was initially thought the hydrogen came from uncovered fuel in the pool.
- Water was added to the pool by fire engine, helicopter, and concrete pump.
