Modeling Potential Impacts of Heavy Metals and BTEX Compounds from the former Year-A-Round Cab Company on Hiniker Pond

MODELING POTENTIAL IMPACTS OF HEAVY METALS AND BTEX
COMPOUNDS FROM THE FORMER YEAR-A-ROUND CAB COMPANY ON
HINIKER POND.

A Thesis Submitted in Partial Fulfillment of the

Environmental Science

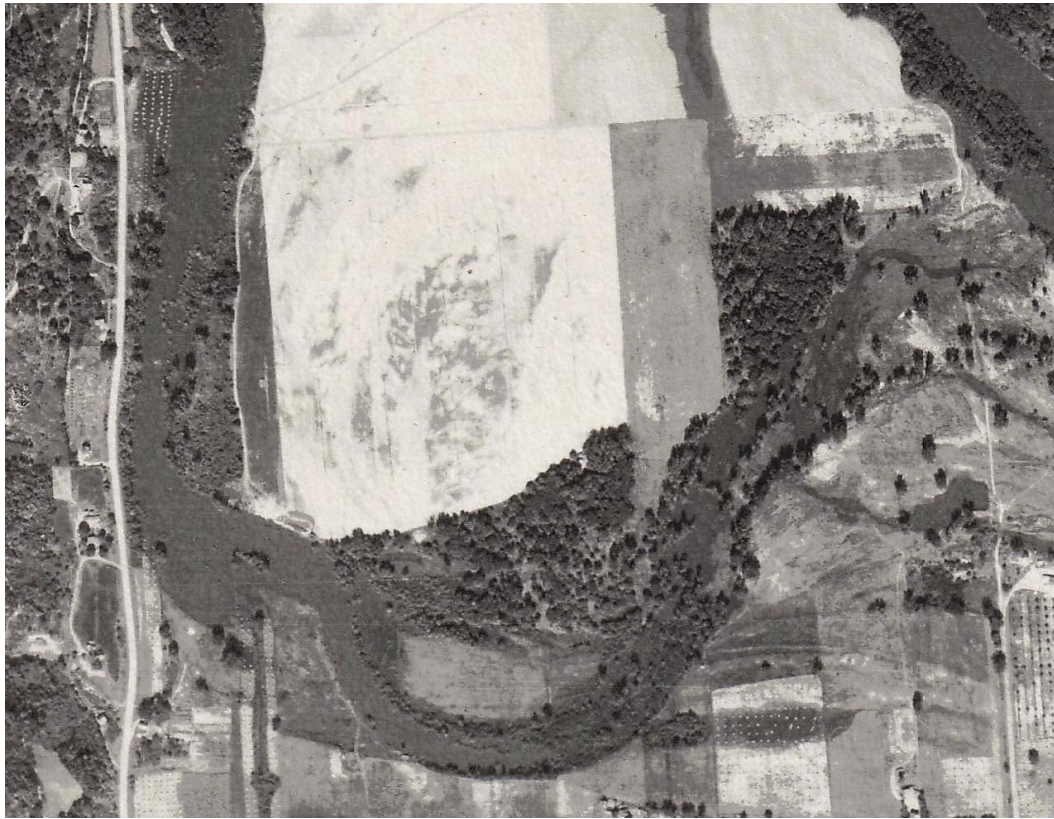
Figure 7. Aerial view of future Hiniker Pond Mankato, MN in 1938 before excavation (USDA 1938)

Hiniker Pond (MNDNR Lake # 07-014700) is an 18-acre pond with a maximum depth of 21 feet and an average depth of 9 feet (Minnesota DNR, 2007; United States, 1980). The site where Hiniker Pond is located, Government Lot 2 in Section 1 Township 108 North, Range 27 West, was purchased by the Hiniker family, on January 25, 1936 (Blue Earth County Minnesota, 1936). In 1936 the land was very close to the Minnesota River and was part of a meander that had not been previously farmed (Figure 7.)

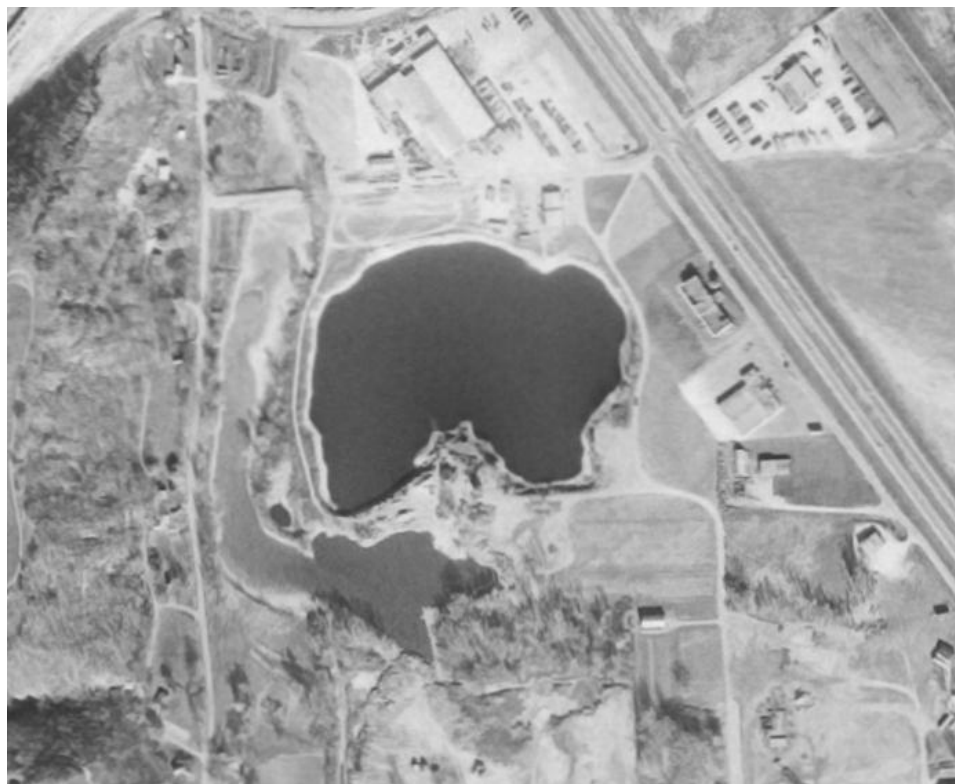
Figure 8. Aerial view of Hiniker Pond Mankato, MN in 1973 at cessation of mining

When Mr. Hiniker began plowing the property he found that the land was almost pure gravel and sand so he started a sand and gravel company on the site (Preuhs, 1998). He found that the water table was only 2-3 feet deep, which led him to start a mining process known as “slack line cable-way mining“ (Preuhs, 1998). In 1946 Joseph Hiniker sold the gravel pit to his son for five thousand dollars (Blue Earth County Minnesota, 1946). From 1946 until it was closed in 1972, approximately one million cubic yards of sand and gravel were removed from the gravel pit site (Preuhs, 1998). Due to urban sprawl and impending retirement, John Hiniker sold the closed gravel pit to the City of Mankato, Minnesota for one dollar on August 12, 1975 (Preuhs, 1998; Blue Earth County Minnesota, 1975; Fischenich, 2009). An aerial view of Hiniker Pond and nearby Oxbow Lake can be seen in Figure 8.

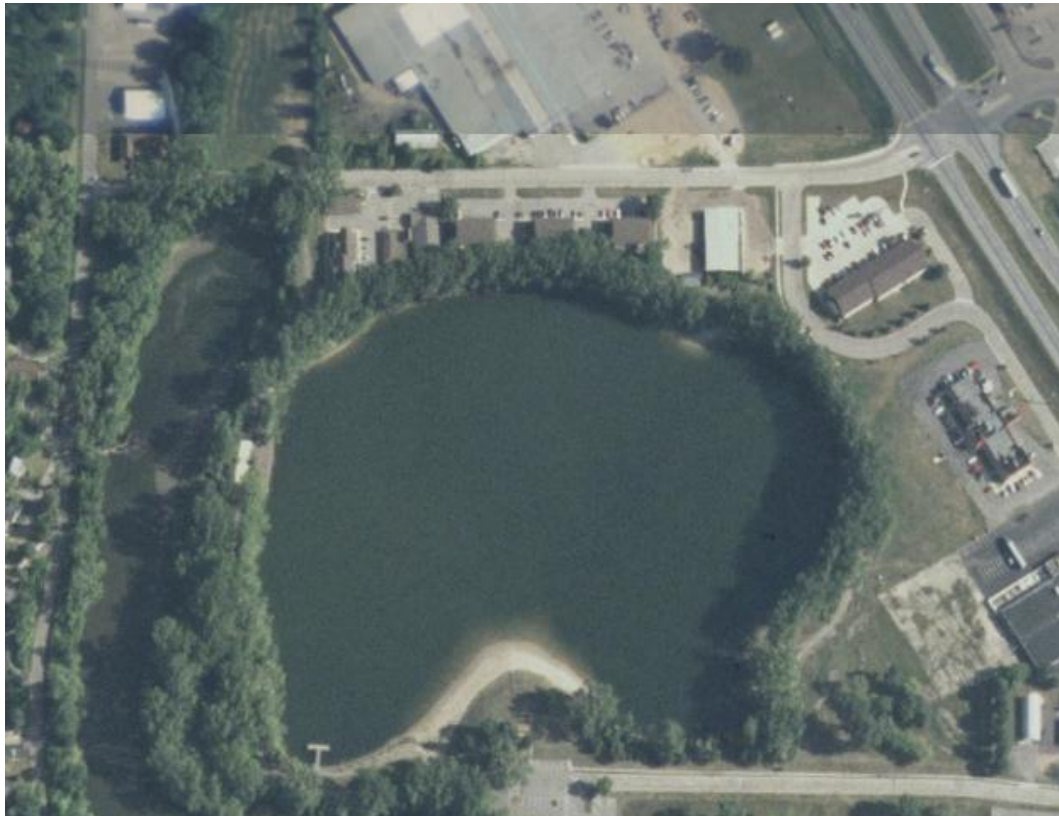
Figure 9. Aerial view of Hiniker Pond and Oxbow Lake, Mankato, MN in 2009
(USDA 2009)

In the 1980's Hiniker Pond was a very popular "rebel swimming hole" so the City of Mankato worked with the ACOE to develop the pond and surrounding property into the multi-use recreational park that it is today as seen in Figure 9 (United States, 1980).

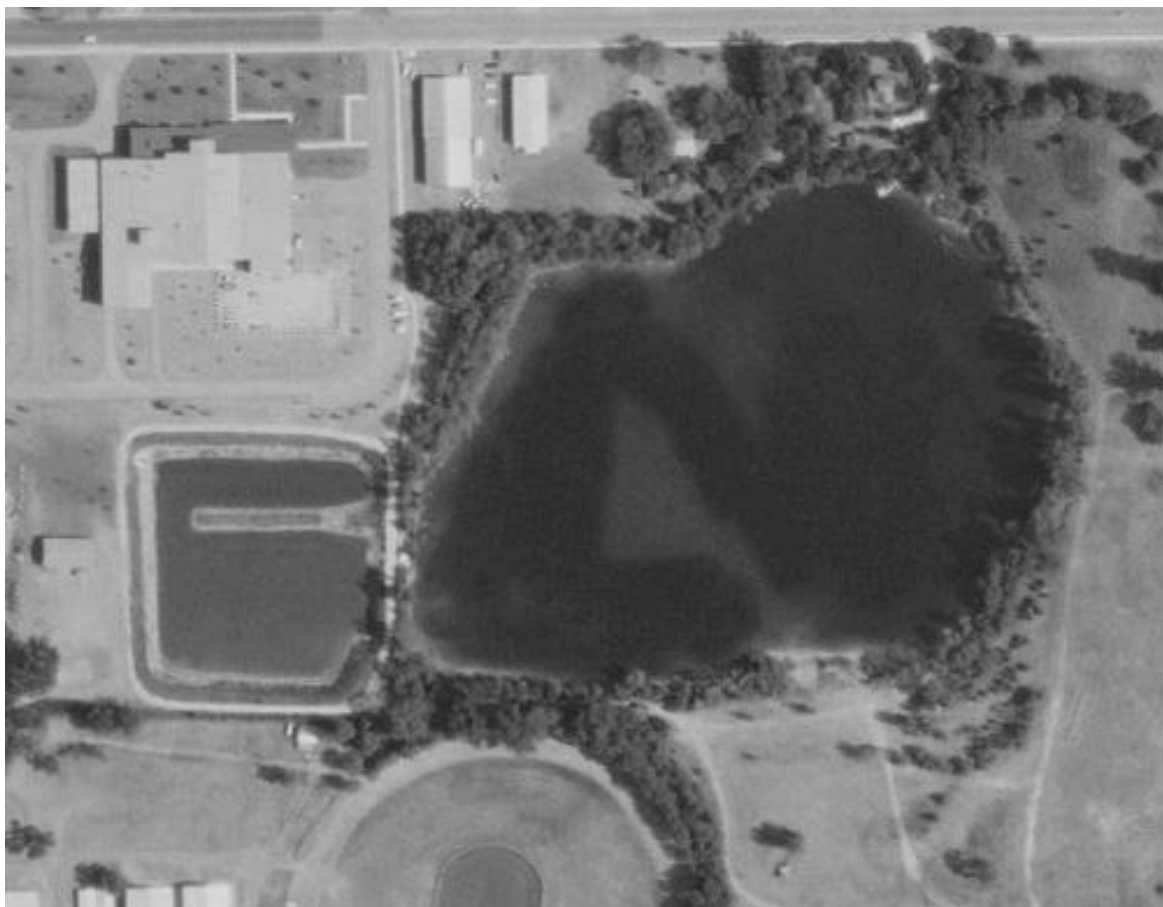
Figure 13. Aerial Photo of Hallett's Pond 2009

Hallett's Pond is 12 acres in size, has a maximum depth of 35 feet, and is very similar to that of Hiniker Pond as you can see in Figure 13. (Minnesota DNR, 1999). Immediately next to Hallett's Pond is a new storm water run-off holding pond, which is connected to Hallett's pond by an overflow grating. Occasionally, the new storm water pond receives untreated sewage from the adjacent wastewater treatment plant (Linehan, 2007).

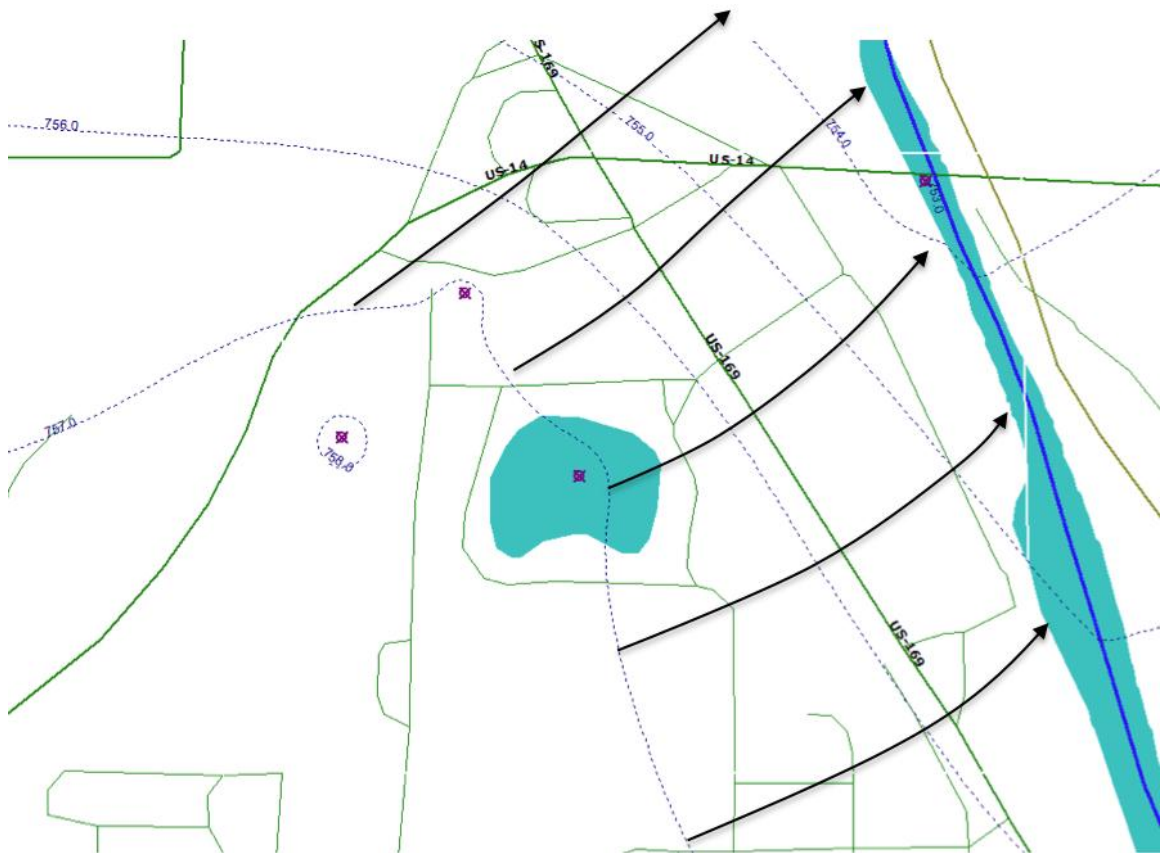
Figure 14. GFLOW model results showing estimated subsurface water flow for Hiniker Pond and surrounding areas, North Mankato, MN

The results of the GFLOW model are shown in Figure 14. The flow lines show that the majority of the aquifer (groundwater) flows to the northwest into the Minnesota River.

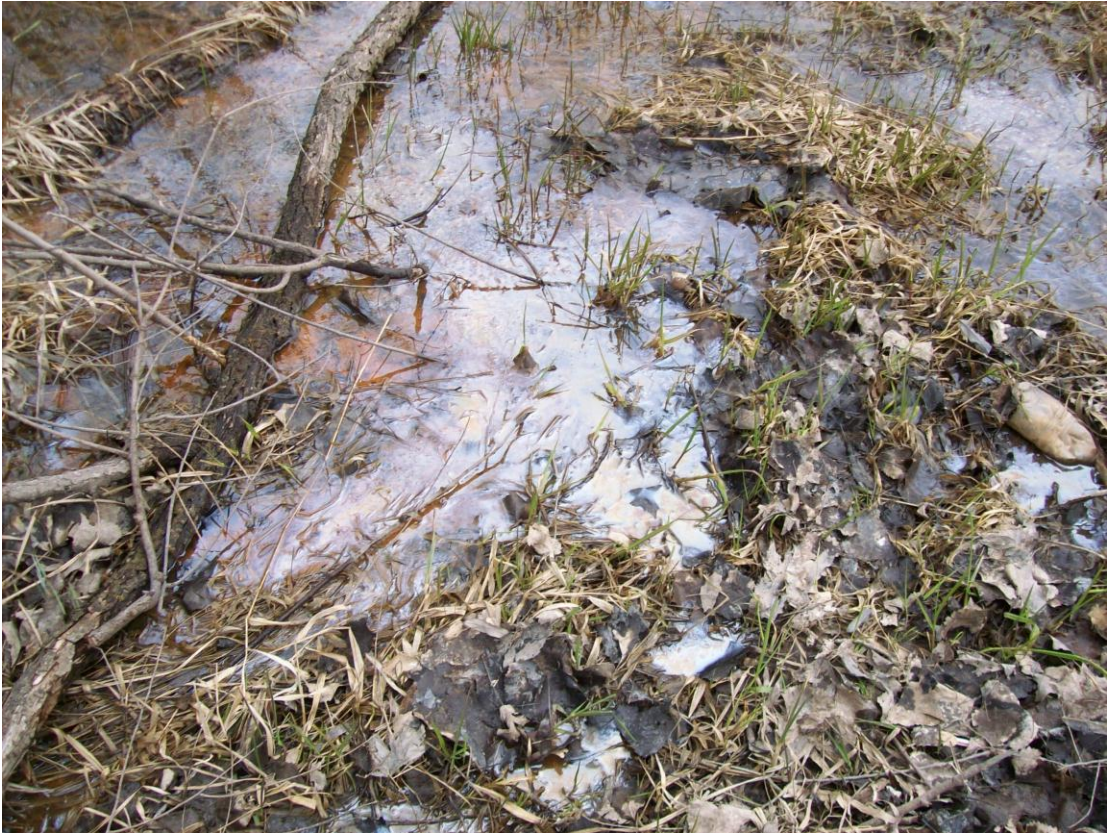
Figure 23. Heavy sheening present in Oxbow Lake on May 19, 2011

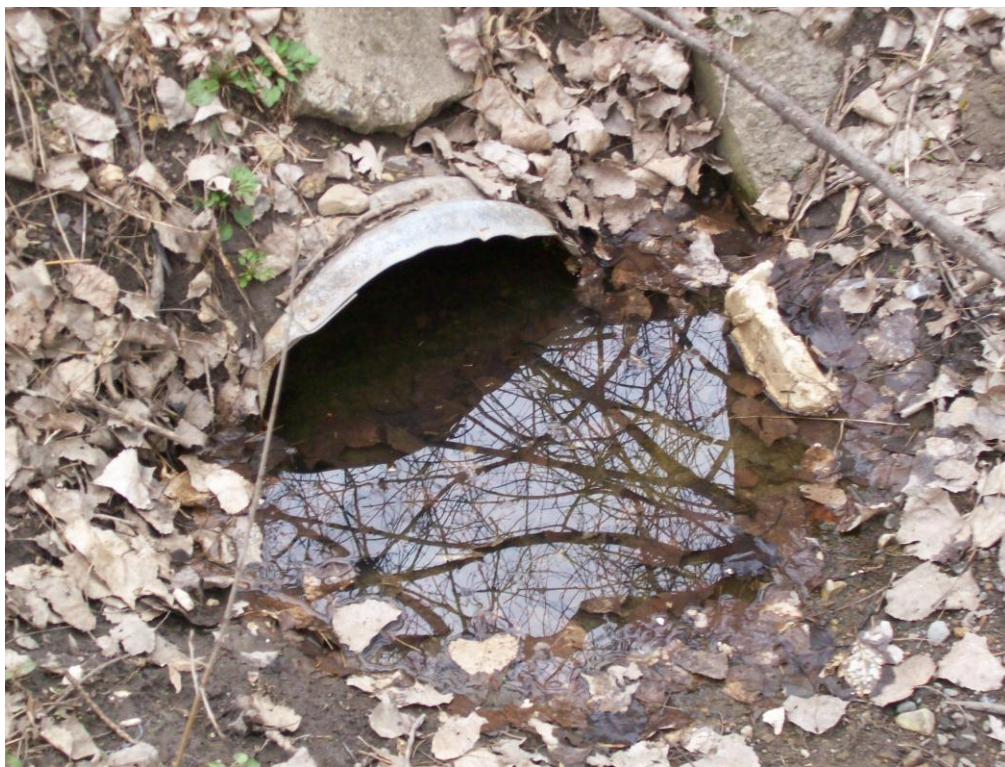
Figure 24. Drainpipe confirmed by MPCA to be running from internal drains of former Year-A-Round Cab Company into US-14 Ditch with sheening and discoloration.

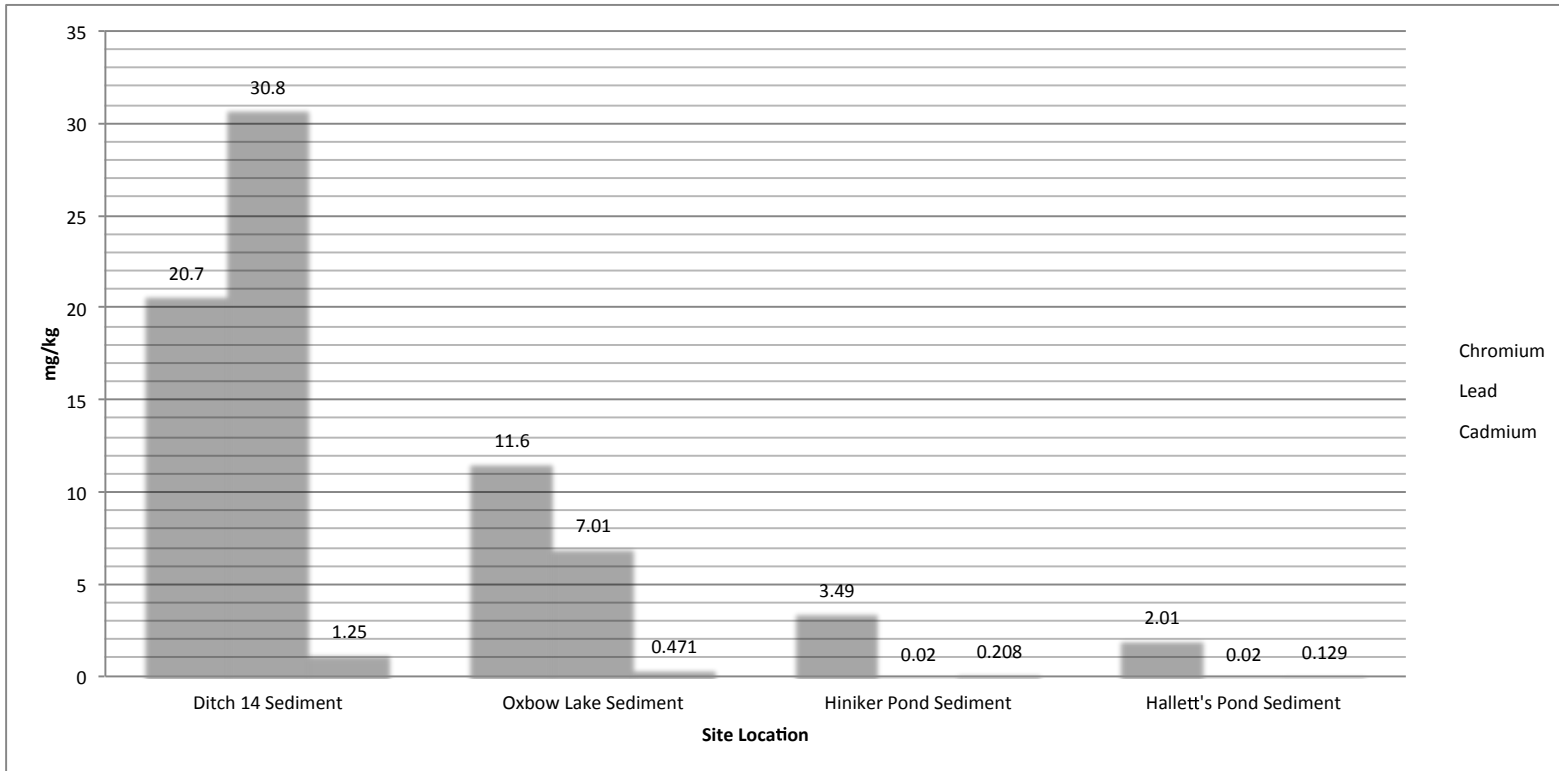
Figure 25. Heavy metals found in sediment at study locations, May 19, 2011

Heavy metals, Cr, Pb, and Cd, were found in sediment samples at varying levels. The US-14 ditch sediment had 30 times higher level of Pb than sediment collected from Hallett's Pond. US-14 ditch had 10 times higher levels of Cd and Cr than Hallett's Pond. These data are shown in Figure 25. Oxbow Lake, which is directly down stream from the US-14 ditch, had 4-5 times higher levels of Pb, Cd, and Cr than Hallett's Pond. Using Pb as a representative of heavy metals, the MODFLOW MT3DMS model indicated that the metals are being transported by surface runoff.

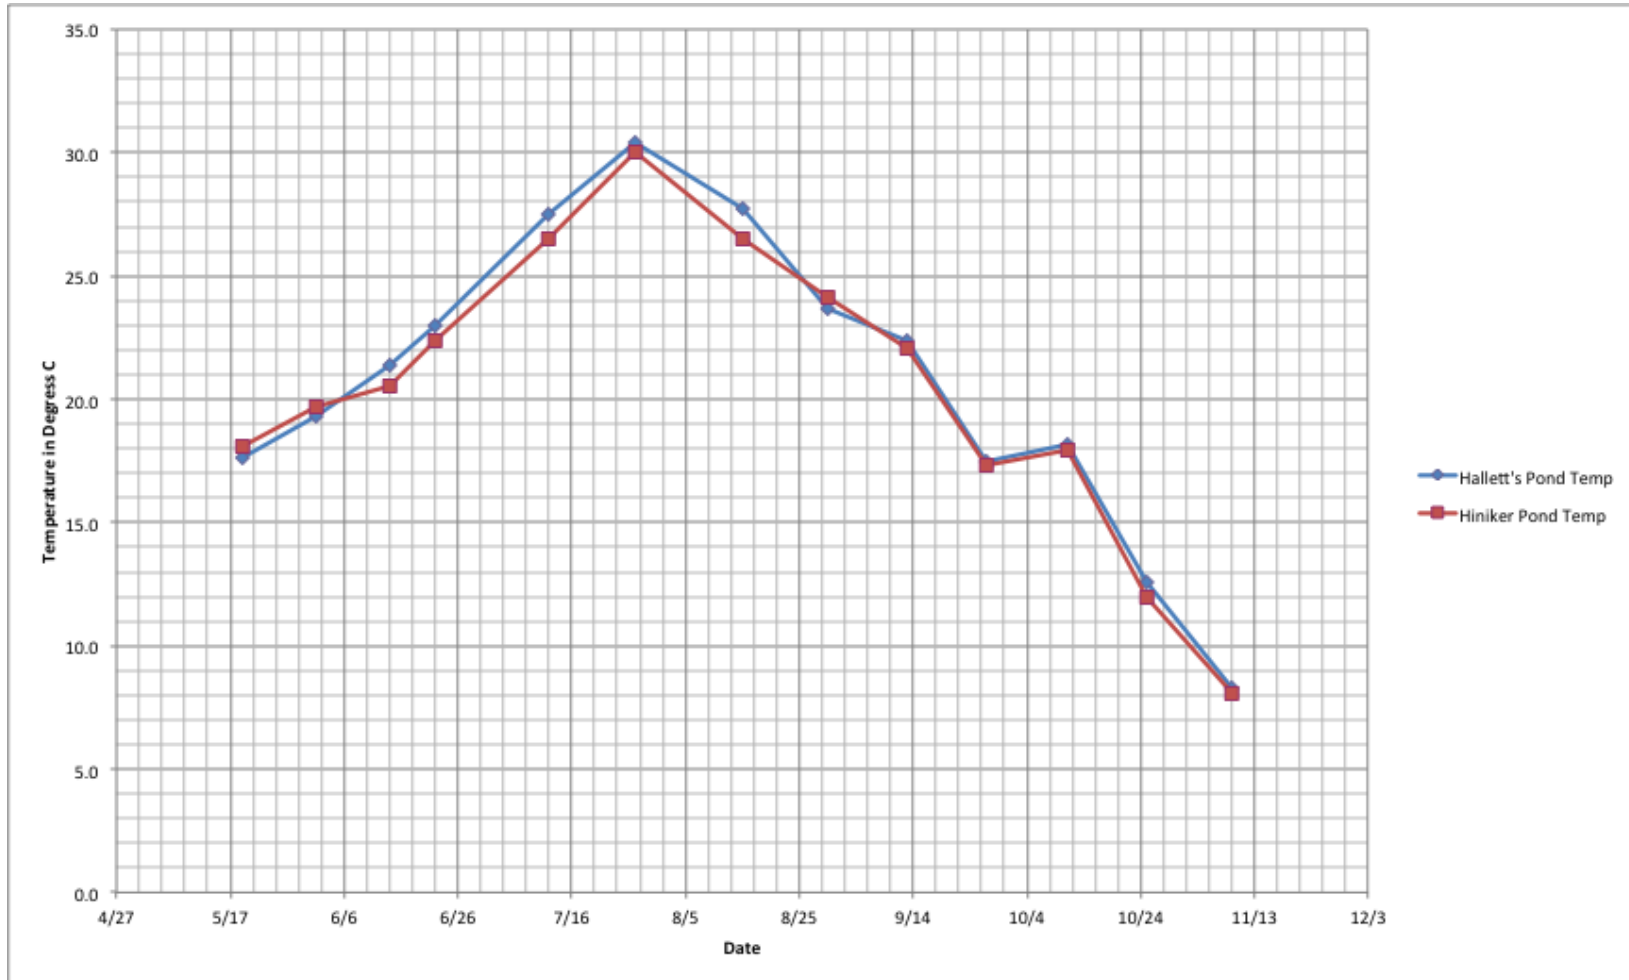
Figure 33. Surface water temperatures in degrees celsius for Hiniker and Hallett's Ponds May - November 2011.

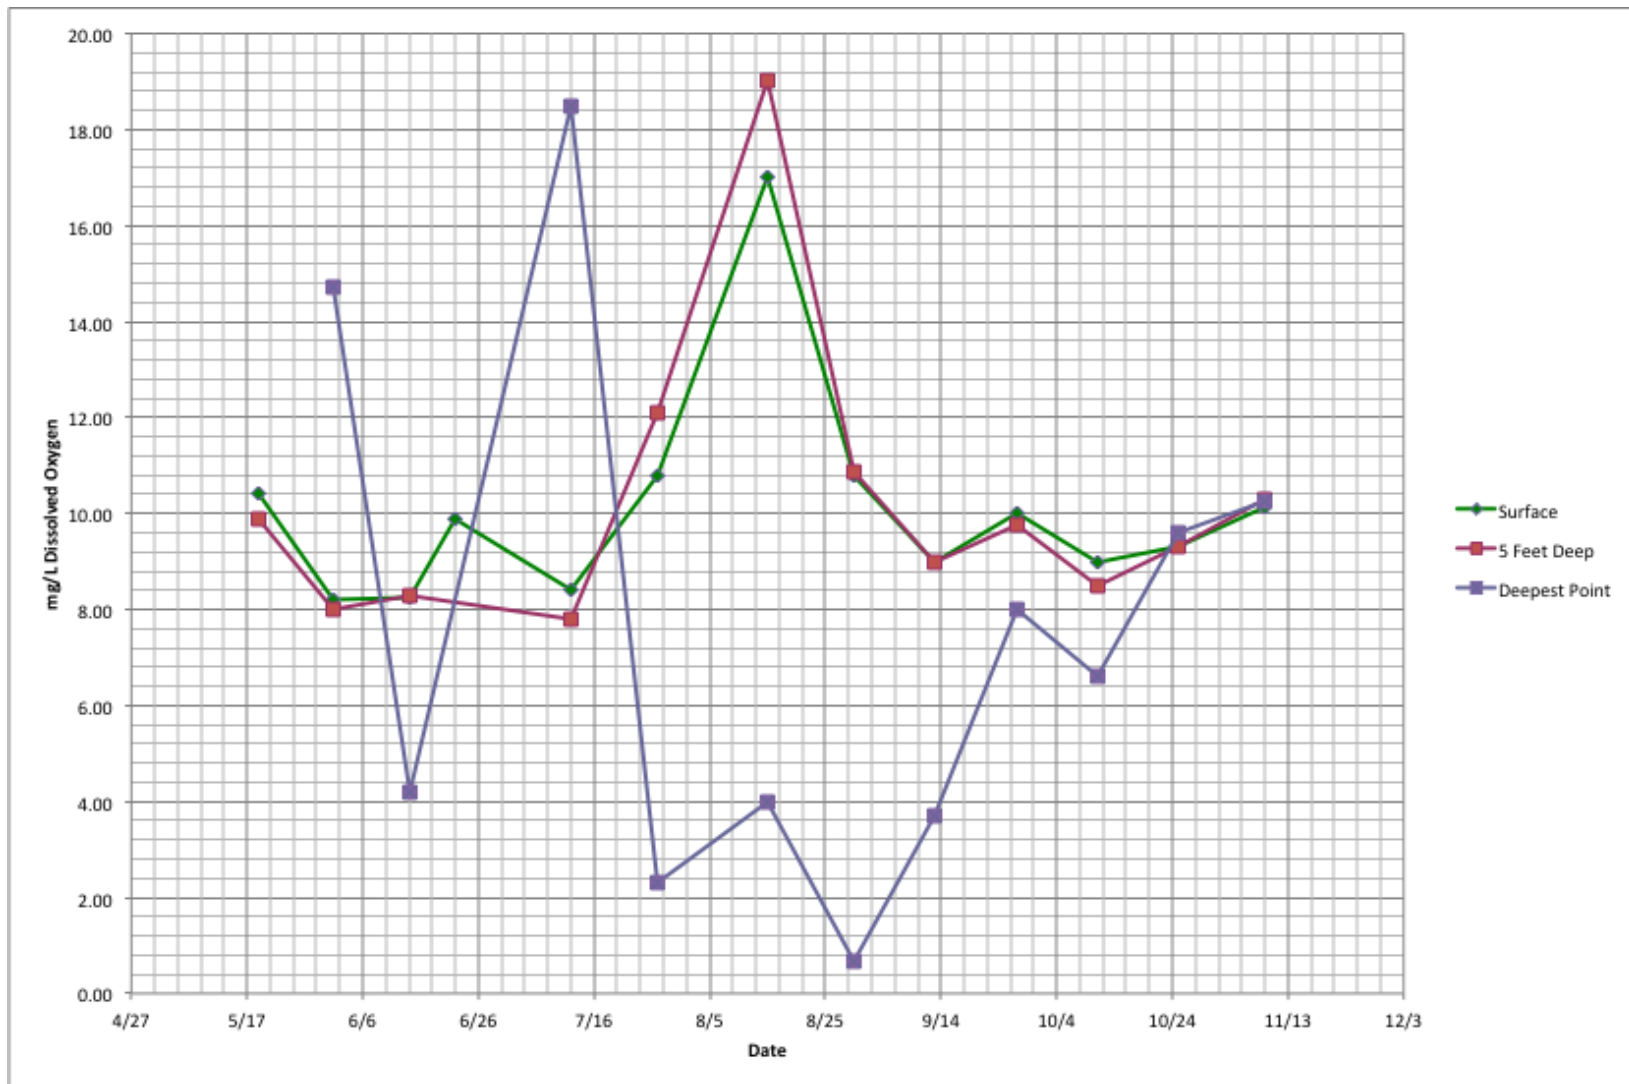
Figure 36. Dissolved oxygen levels in Hallett's Pond measured in mg/L at 5 foot interval May- November 2011

For Hallett's Pond DO levels in the surface and 5 foot levels also remained above 8 mg/L and was even supersaturated in August. Supersaturation was probably due to algae photosynthesis. In the deepest water, the DO level was less than 2 mg/L 1 out of 13 times. There was a dramatic increase in DO levels in the deepest waters July 14th. This data point is suspect.
