# Breakouts & Pinholes test results in real-life test conditions

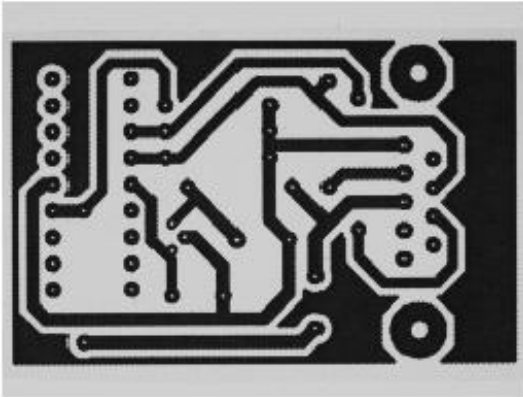
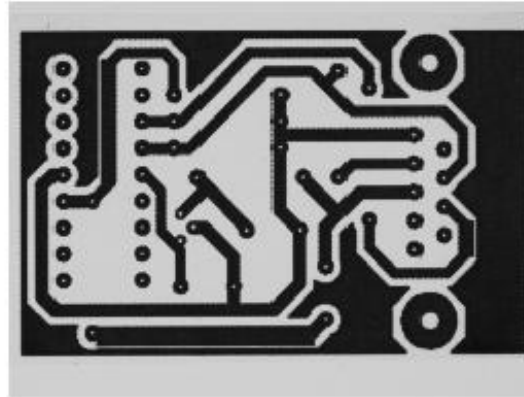
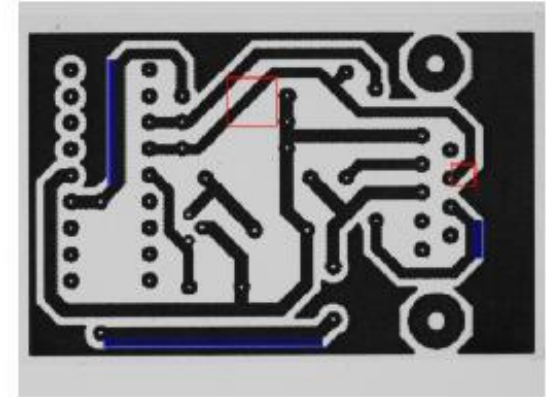
# Conductor too close test results in real-life test conditions

Templet Image

Inspection Image

Defects

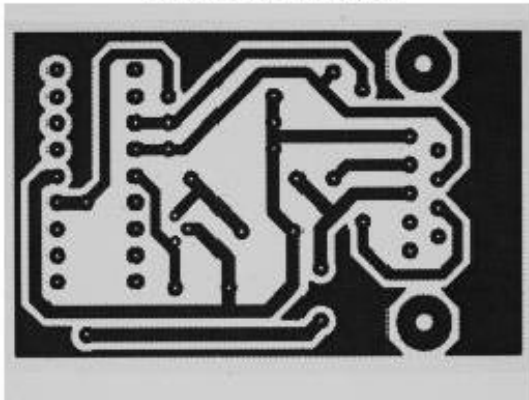
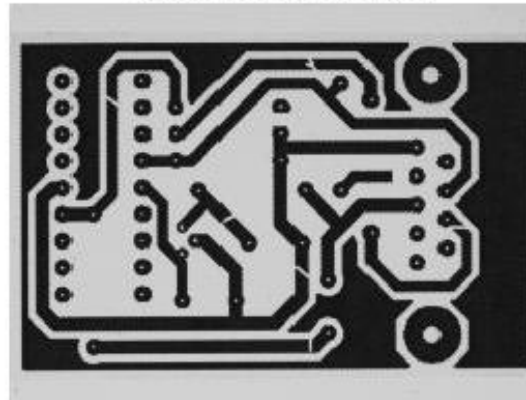
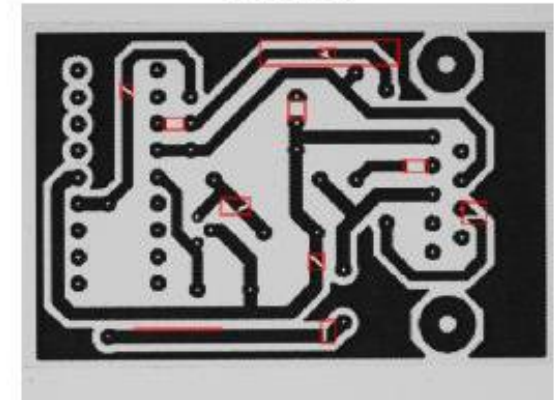
# Missing Conductor & Open circuits test results in real-life test conditions

Templet Image

Inspection Image

Defects

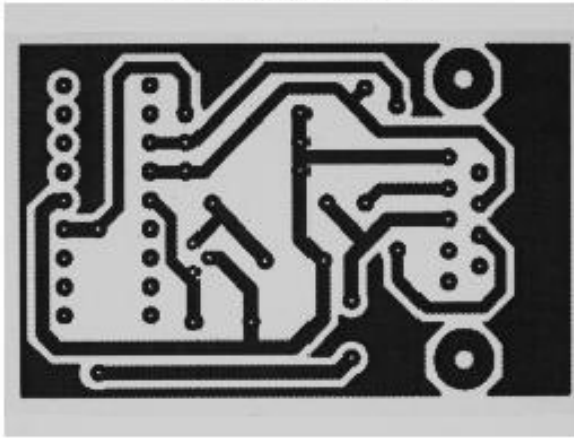
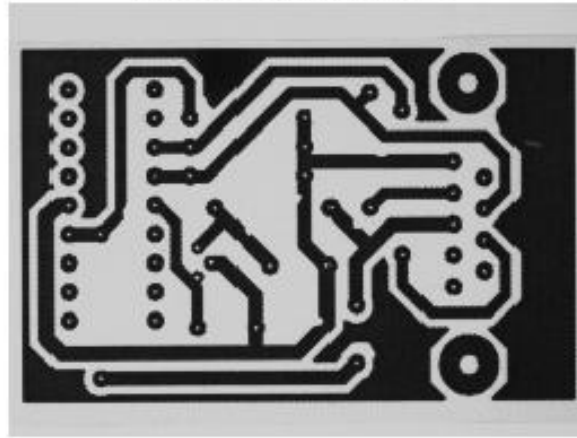
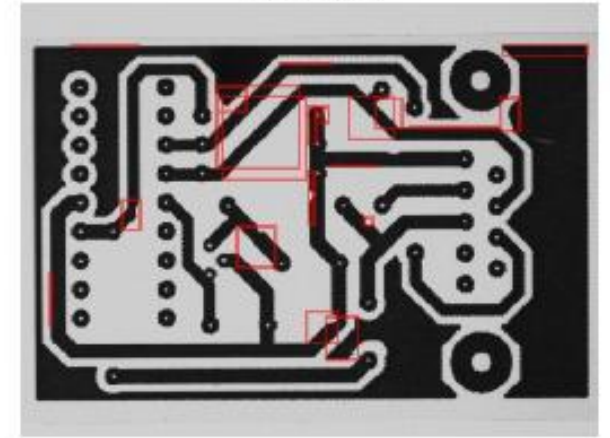
# Mouses bite & Over etch test results in real-life test conditions

**Templet Image**

**Inspection Image**

**Defects**

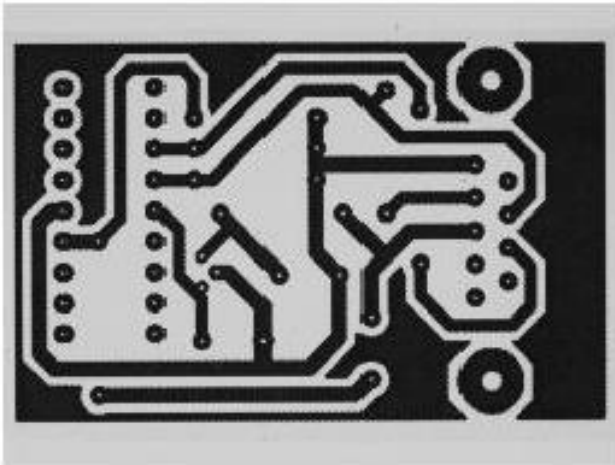
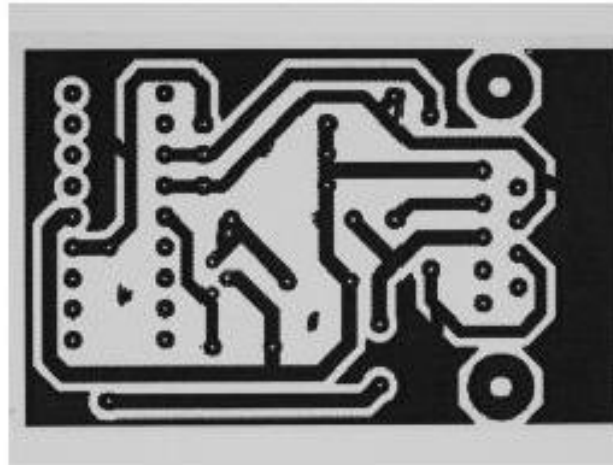
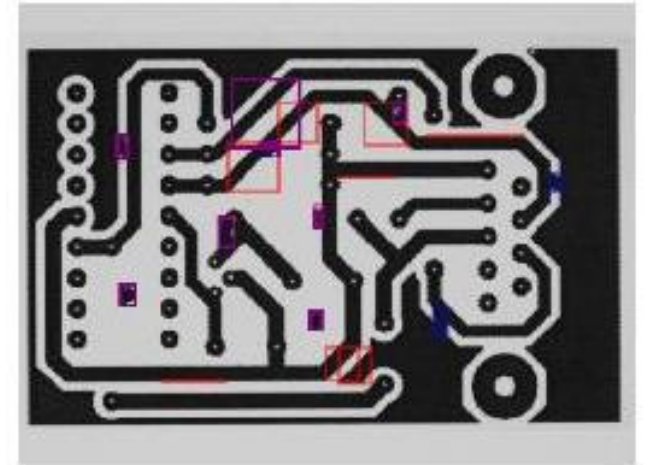
# Spur, Spurious copper, Excessive Shorts & Shorts test results in real-life test conditions

Templet Image

Inspection Image

Defects

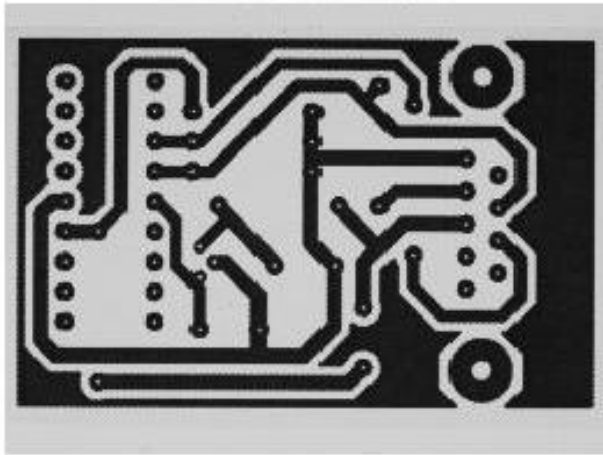
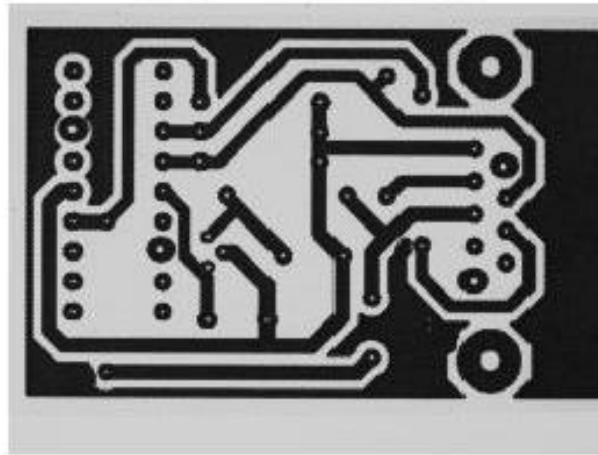
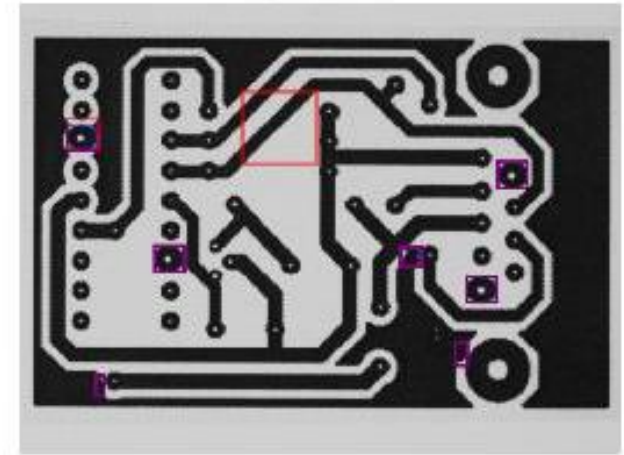
# Under etch test results in real-life test conditions

Templet Image

Inspection Image

Defects

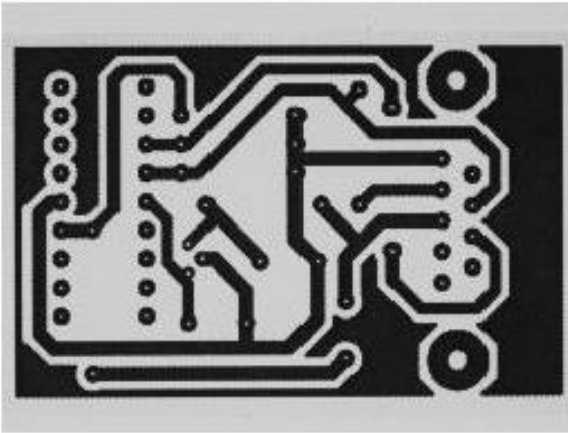
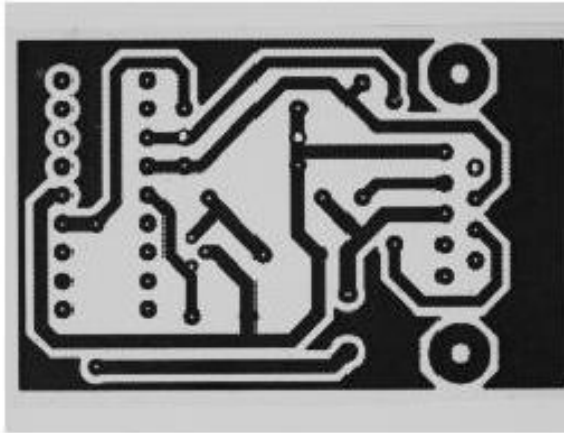
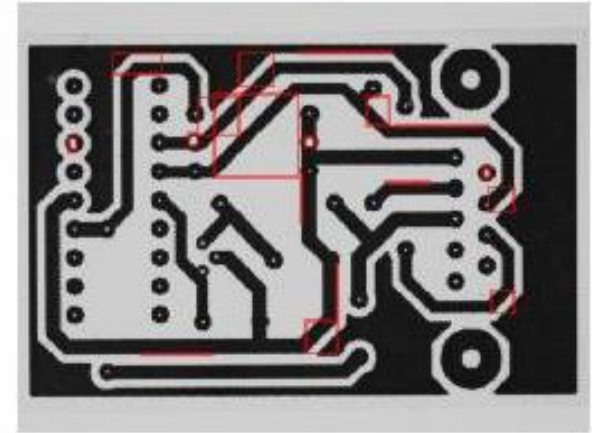
# Wrong size hole & Missing hole test results in real-life test conditions

Templet Image

Inspection Image

Defects

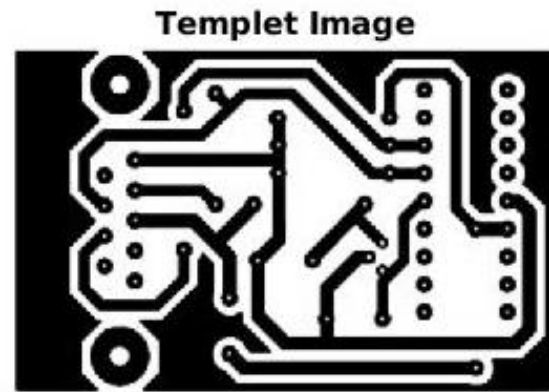
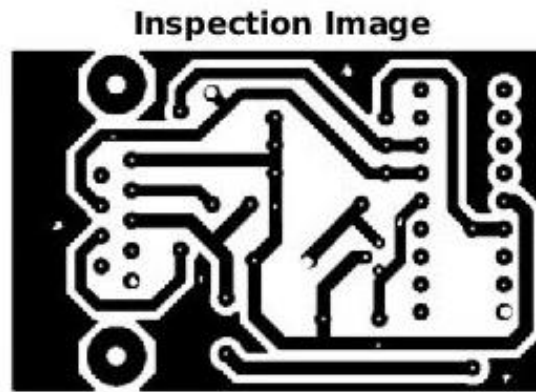
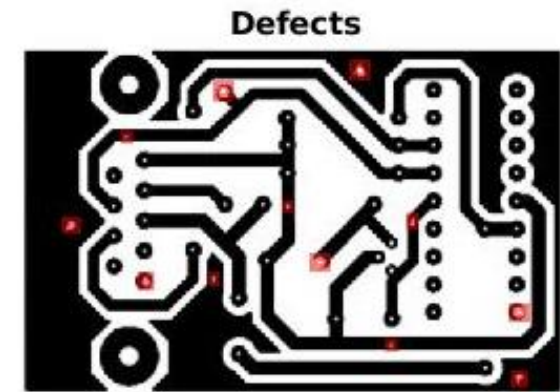
# Breakouts & Pinholes test results in ideal test conditions

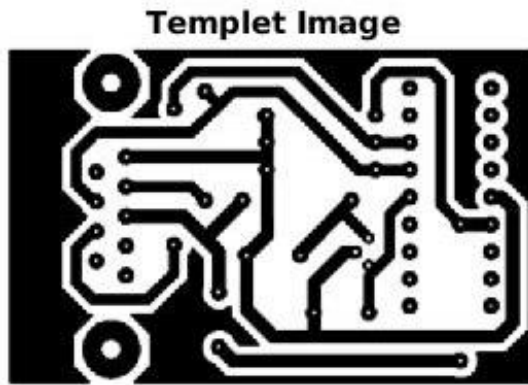
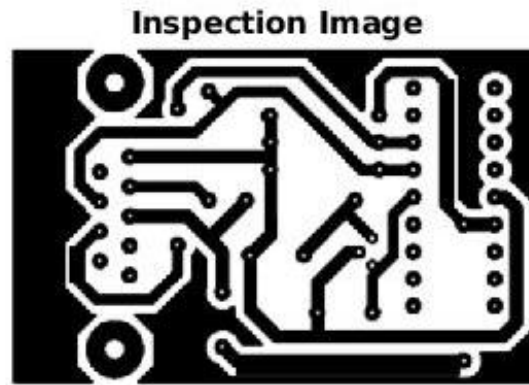
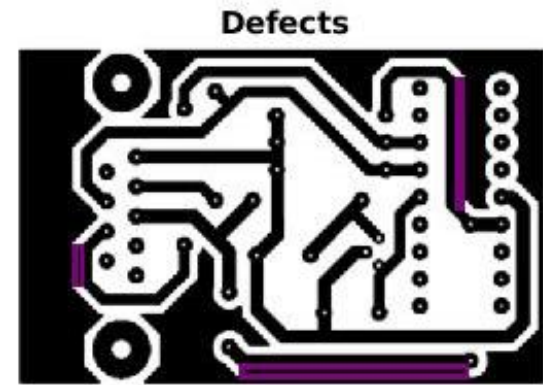
# Conductor too close test results in ideal test conditions

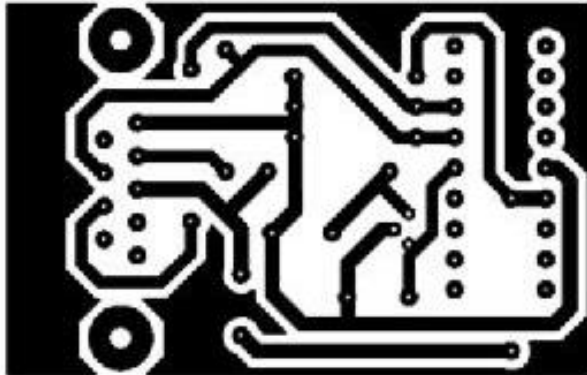
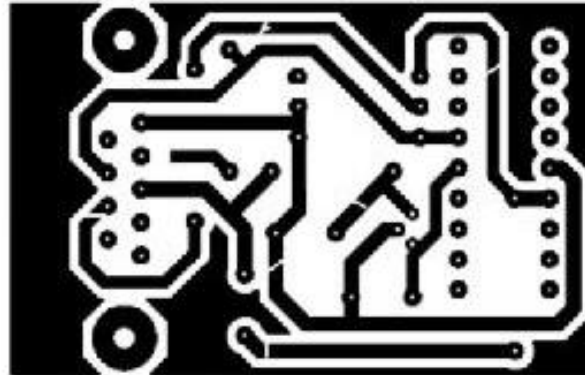
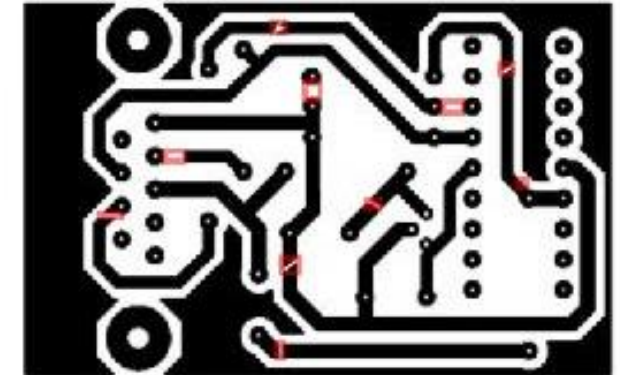
# Missing Conductor & Open circuits test results in ideal test conditions

Templet Image

Inspection Image

Defects

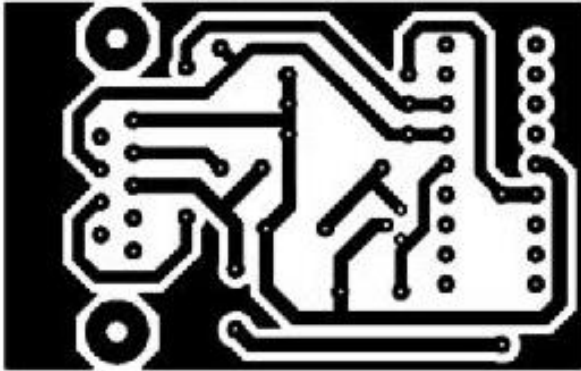
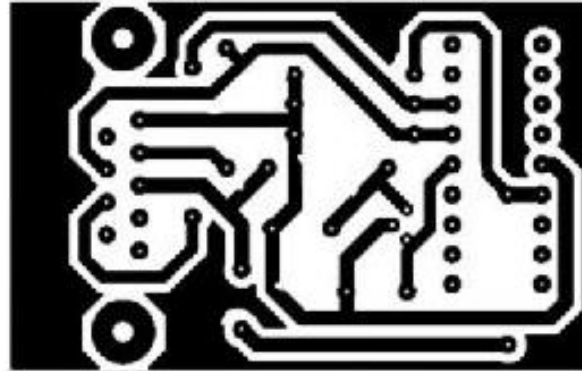
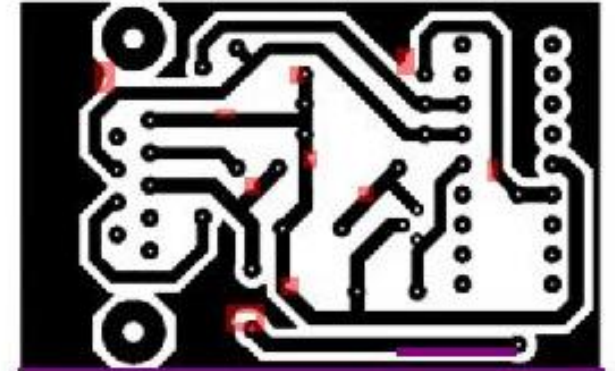
# Mouses bite & Over etch test results in ideal test conditions

Templet Image

Inspection Image

Defects

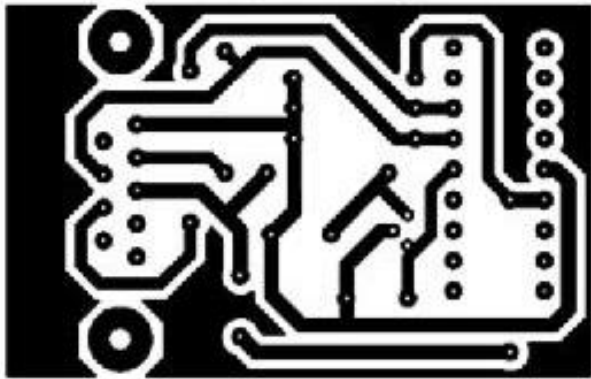
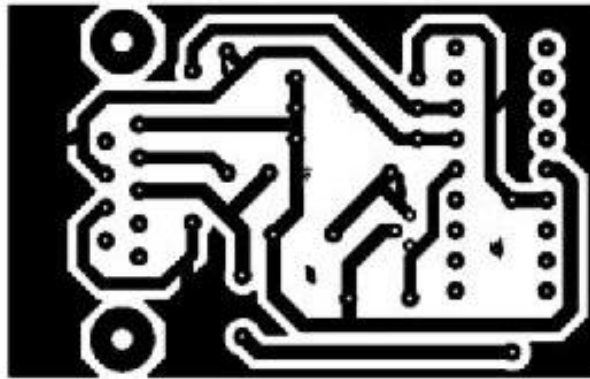
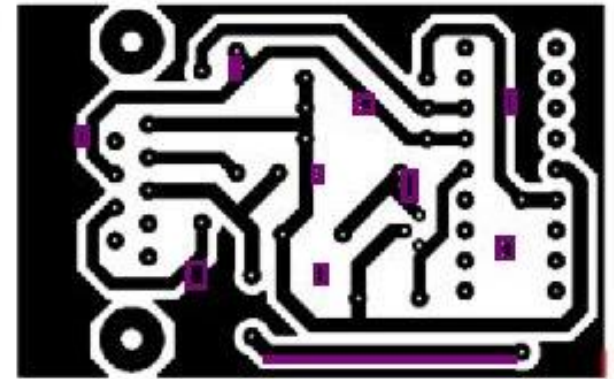
# Spur, Spurious copper, Excessive Shorts & Shorts test results in real-life test conditions

Templet Image

Inspection Image

Defects

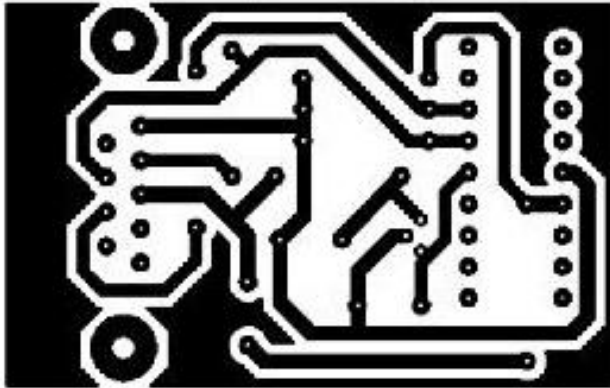
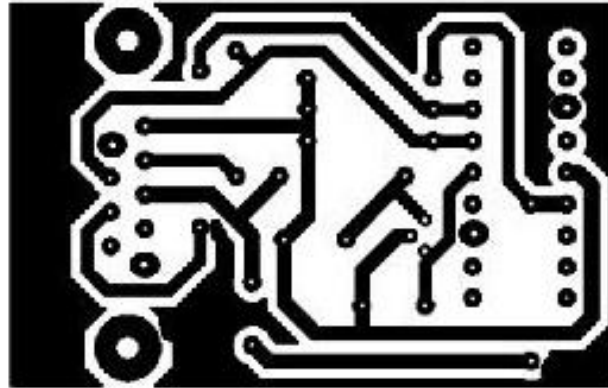
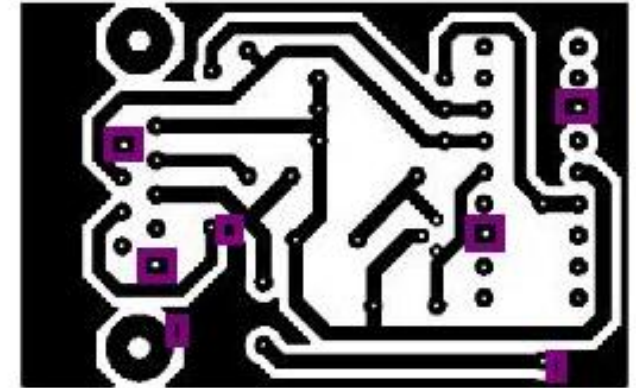
# Under etch test results in real-life test conditions

Templet Image

Inspection Image

Defects

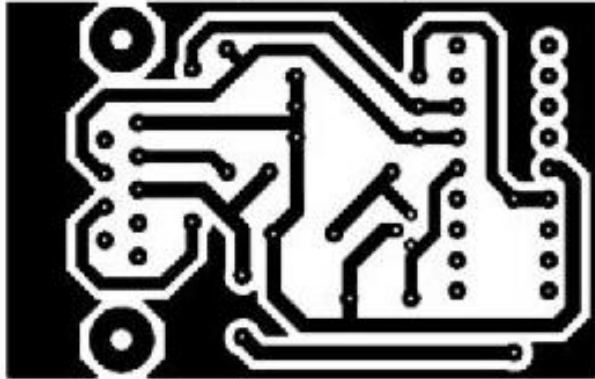
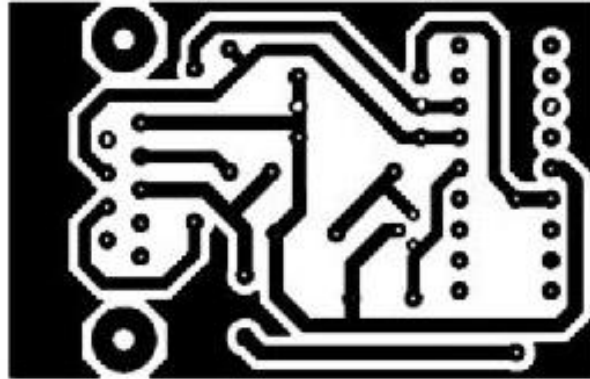
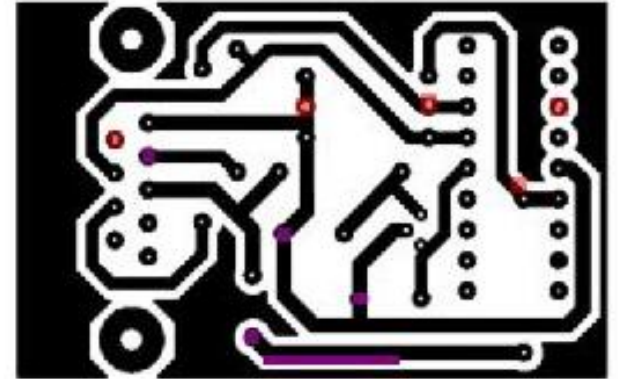
# Wrong size hole & Missing hole test results in real-life test conditions

Templet Image

Inspection Image

Defects
